Shifter support spring

The support springs mount in the housing and centers your shift lever.

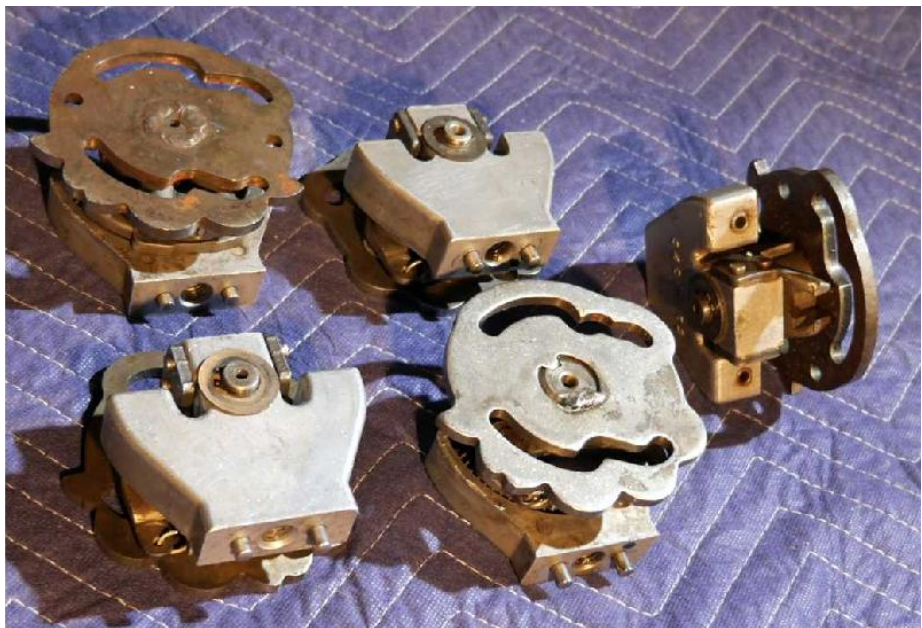
The Iron Sportster trap door assembly holds the mainshaft, countershaft, and shifter mechanism.

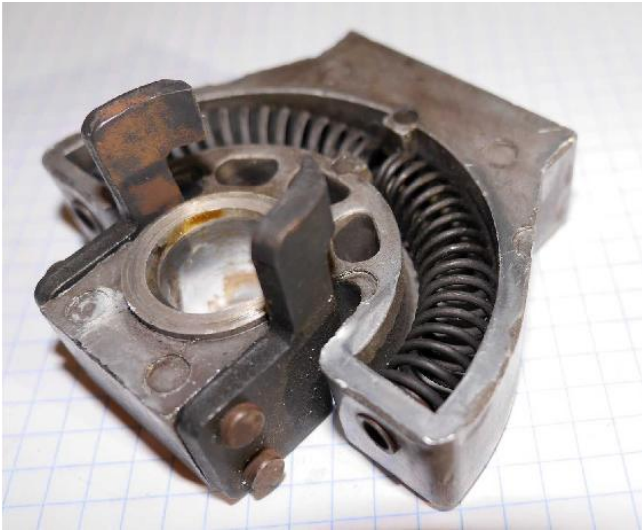
The Iron Sportster shifter comes as the 34009-52 assembly.

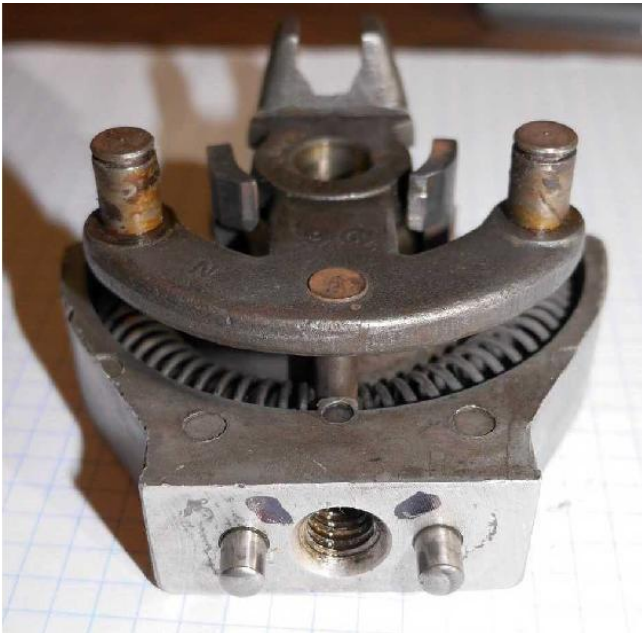
Here is a view of the two shifter support springs as installed in the housing. At rest, they press against those square features, they do not bear on the pin in the shifter carrier that they center.

Here is the housing with the carrier partially installed. You can see how the spring stops are as wide as the pin in the carrier. This way the springs don't fight each other as they center the carrier and hence, the shifter lever.

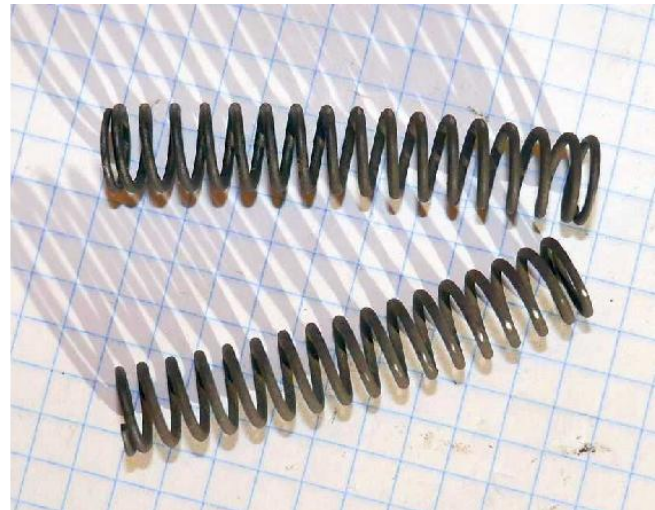
Here are two of the springs, I'm guessing the -52C parts. .

The springs tend to bend into an arc from riding in the housing for years. This might be due to losing their temper, or to the springs wearing in a certain way.

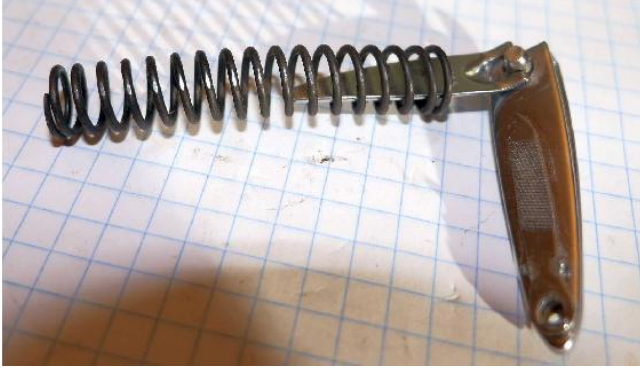
My buddy Angel had one of these break in his 1979 Sportster. Looking at this one, you can see why. The coils are worn a little flat. These aren't too bad, but you can see how it could develop into a real problem.

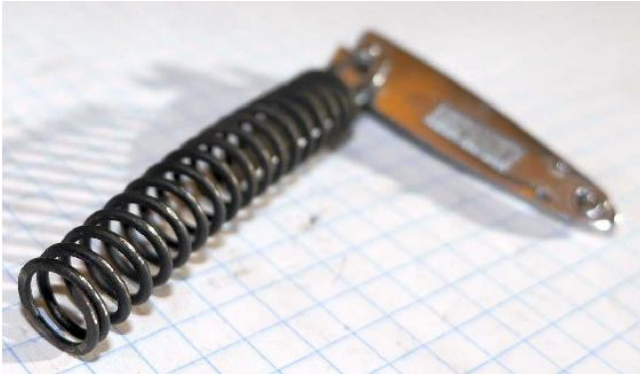
This view shows how the wear is worse on one end of the spring. If you are in the tranny, it might be a good idea to carefully inspect these springs and replace any that are worn flat anywhere.
